Adaptive Re-Use Building at Historical District

Case study: Heritage the Factory Outlet

Nurtati Soewarno

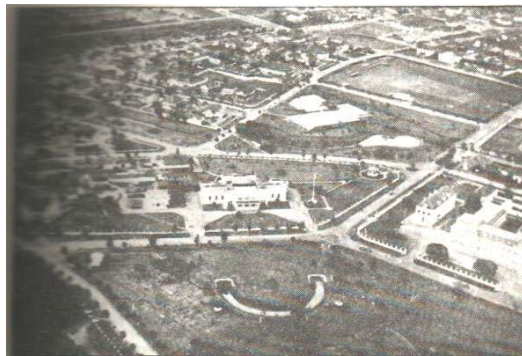
Picture 1: Bandung's new city centre.

This district laid between Insulinde Park and Gedung Sate, which includes the residence of The High Commander of the Dutch Indishe Army, War Department building (1916) and housing for European. It was a first elite area in Bandung. A well known architect, Hendrik Petrus Berlage, who visited Bandung in 1923 called this area as a 'prototype of Indishe Colonial city'.

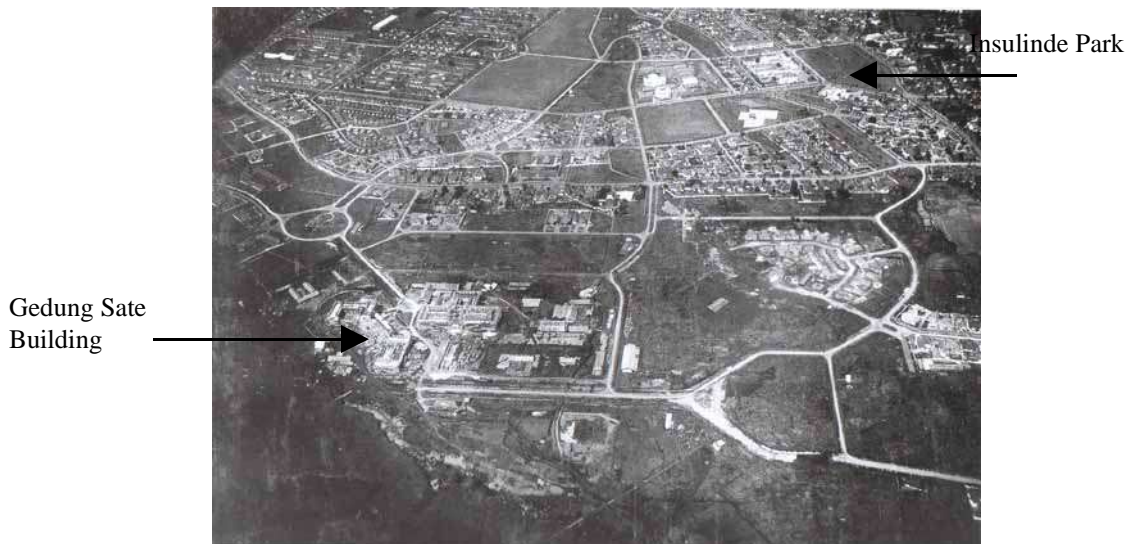
Picture 2: This district then becomes the beginning point of the North Bandung development plan in the year 1919. (Voskuil, 1996, Bandoeng Beeld van Eenstad)

This district becomes the beginning point of the North Bandung development plan in the year 1919, the achievement to create an European district in the tropical countries. This district have the street names of cities or regions in Indonesia such as : Aceh street, Ambon street, Riau street, Maluku park etc As a new city center for Dutch's people this area is taking a strategic position in Bandung city, easy to reach and easy to recognize.

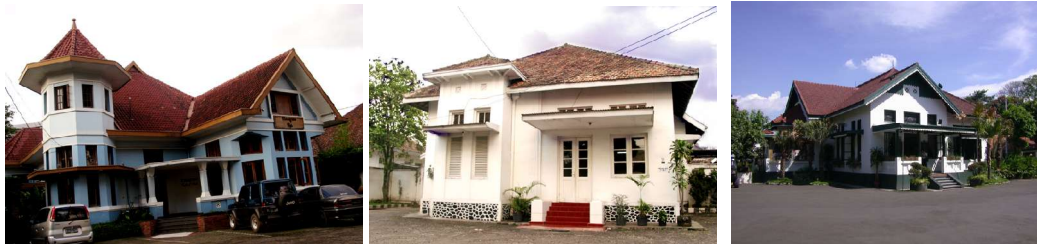
Picture 3: Some of Dutch's houses which still exist in Military area

The tropical climate demand's large door and window sizes, made it possible for adequate sun shine and fresh air flow to enter for natural lighting and good air conditioning to overcome the heat. Large size rooms, as a sample the children room is 5 x 6 meters with more than 4 meter high ceiling, also to overcome the heat. A porch facing the inner yard for coffee or tea time in the morning or afternoon.

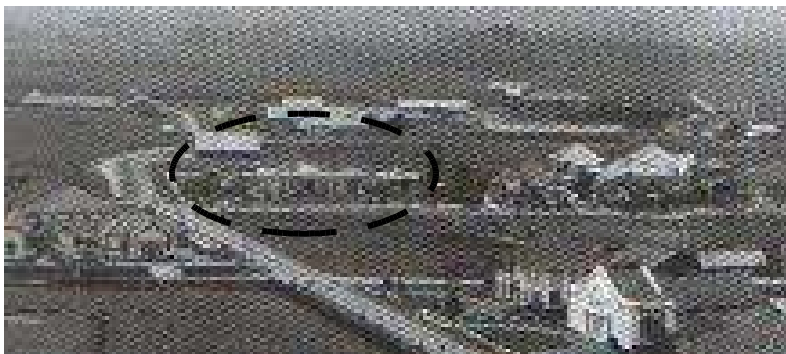
The building is estimated build in the early time of the 20th century. This can be proofed by the usage of flimsy pressed iron plate for ceiling decorations (*gestampt dun plaatijzeren*) which was much produced in Dutch at that time (*en dateren uit het eerste decenium of van de 20ste eeuw*). This building has obtained a lot of design intervention from building owner housewives whose learned from a popular book at that time 'Ounce of Huis in Indie', ('Our house in Indonesia) a masterpiece of Mevrouw Catenius van der Meijden, narrating about hygiene, health, furniture, work, building maintenance and others.

Picture 4: Situation of district surrounding 'Heritage' in 1920 and flimsy pressed iron plate for ceiling decorations (Voskuil, 1996, Bandoeng Beeld van Eenstad)

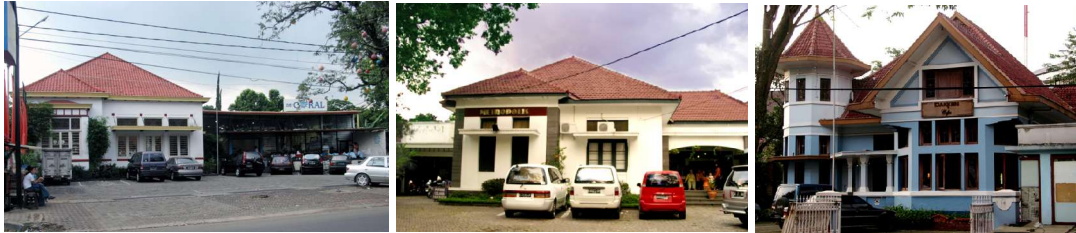
Picture 6: Some old buildings which already changed to be commercial buildings.

This successfulness was followed by others building surrounding which also change to become commercial building like: boutique fashion, cafe shop etc.

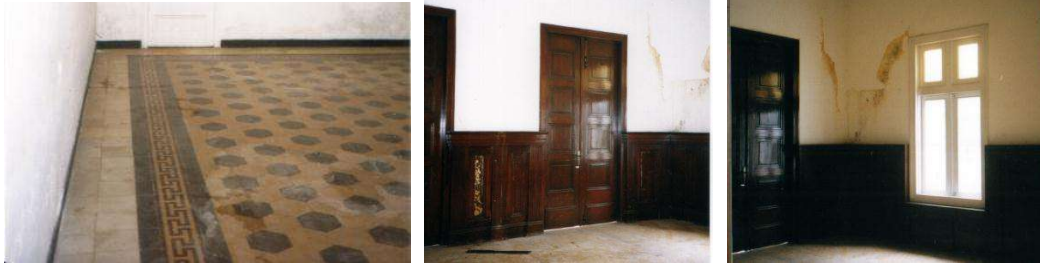
'Heritage' building quilted with the bearing wall structure, red brick wall with pilaster and stone as foundation. Roof use vlam tile, pressed iron plate for ceiling decorations while window and door's frame from the best quality's of teak. Floor used combined artless and decoration of good quality tile.

Picture 8: Details of floor tile and interior existing.

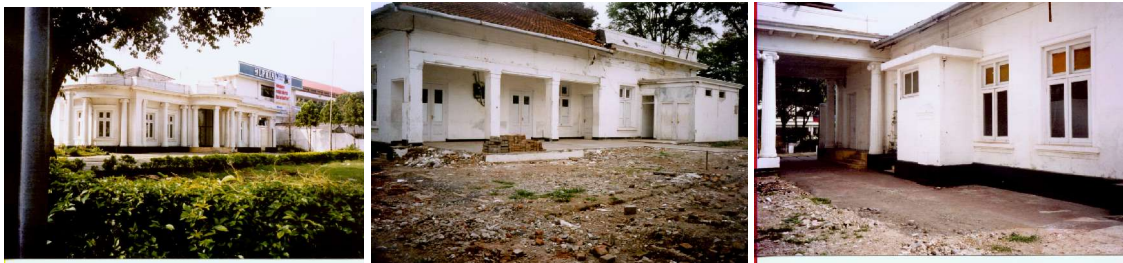
Building condition before revitalization was very bad, roof construction had brittle, 50% of tile had leaked, especially in main entrance. Rain-gutter had leaked, frame of window and door incurred by insect and also the condition of ceiling. The parts which still good looking and strong were pillars. Partly of the yard covered with paving block and cement and used as parking space. The other part still as garden covered by the grass and some trees. One of the trees represents the crop which must preserve.

Picture 9: Building condition before revitalization. (Front, back and side elevation)

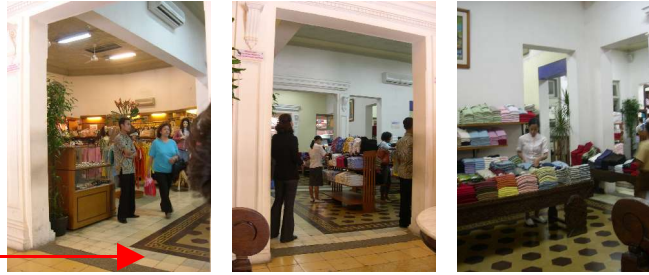
Floor tile motif could recognize the previous room

Picture 12: Continuous show room and side entrance.

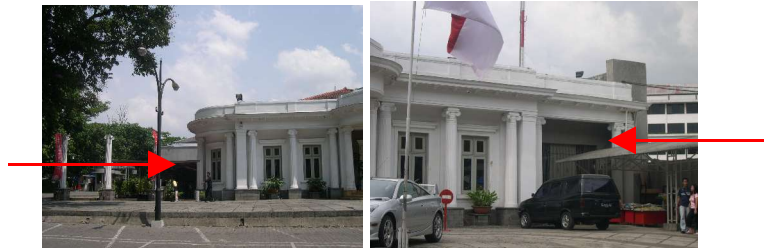
3. Veranda at right side used at bags showroom and also as entrance to cafeteria and alternative of way out
4. Carport used as showroom for bed room's accessory by built wall at front side. In this side room there is a stair to the second floor area
5. Veranda at left side used as locker for visitor. The visitors may not bring the big bag and other things.
6. Toilet used as storage. New toilets have been built at the back side of the building.
7. Kitchen still used as the previous function but now serve for cafeteria.

Picture 13: Cafeteria at right side. Carport at left side which already closed by wall.

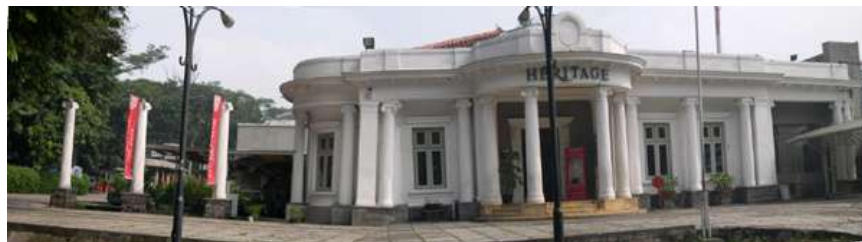
Picture 14: Front elevation of Heritage building.

Addition building has been done maximally using space around the building. The function of the new building at left and back side are showrooms, service room and storage with size 967.5 m² covering 2 (two) storey. The new building at right side is semi permanent, transparent and used as cafeteria sizing 163 m².

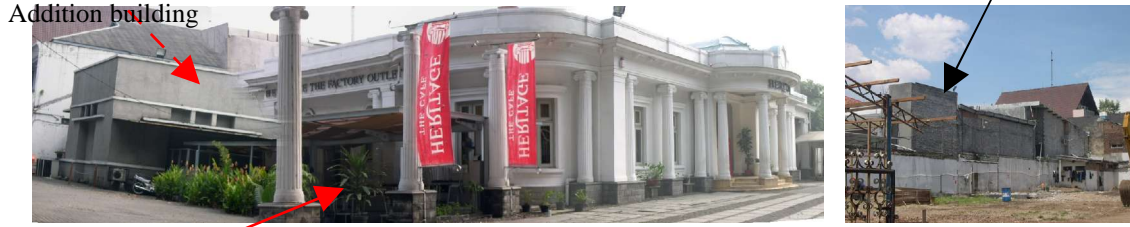
Picture 15: Right and left side elevation of Heritage building.

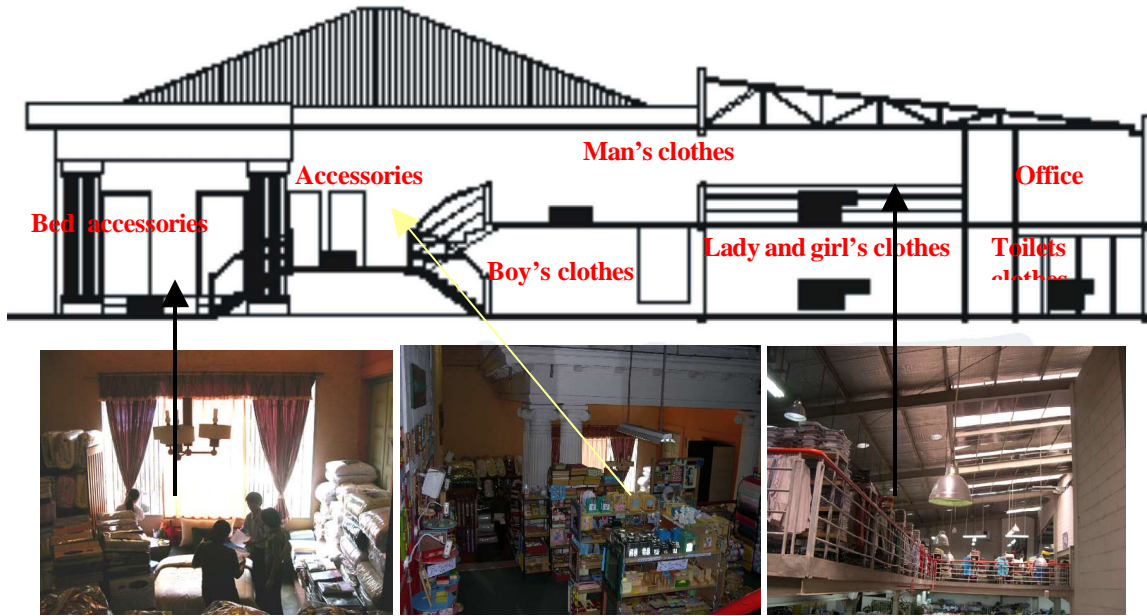
1. Show room at left side building, used as place for accessories, boy's clothes at ground floor and man's clothes at first floor.

Picture 16: Section of addition building at left side, which showing the optimally used of space.

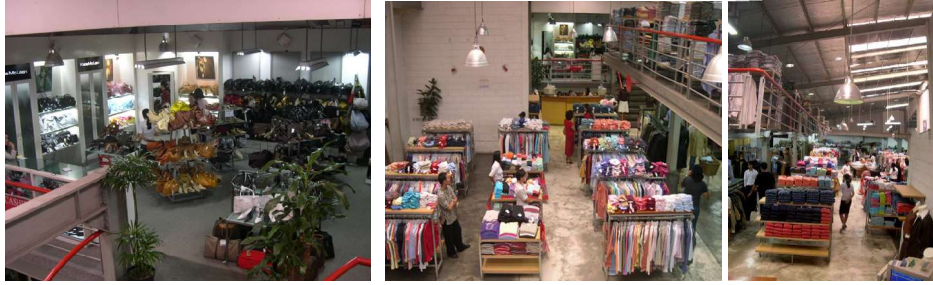
The show room at the back and right part were made separately as a split level floor. At the ground floor in middle and left part is used for lady's, baby's and girl's clothes, fitting room and toilet, while at the first floor is used for man's clothes. Ground floor at right side is used as cashier. Basement at right side is used for man's shoes and lady's bag and shoes.

Picture 17: Section of addition building at back side, which showing the optimally used of space.
